County of San Luis Obispo Onsite Environmental Coordinator  
Guadalupe 8X Sump Removal  
Update 1-20-2016

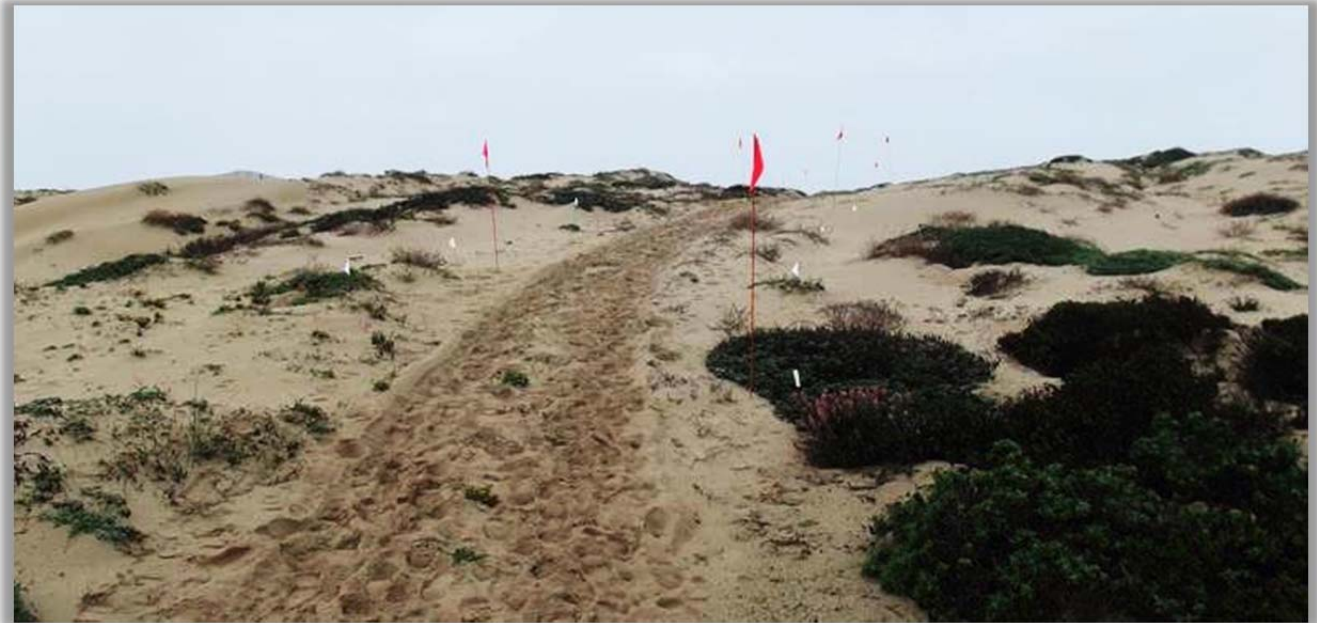
Access corridor along the 7X Road and current ORV Trail used for all equipment access to the 8X Site.

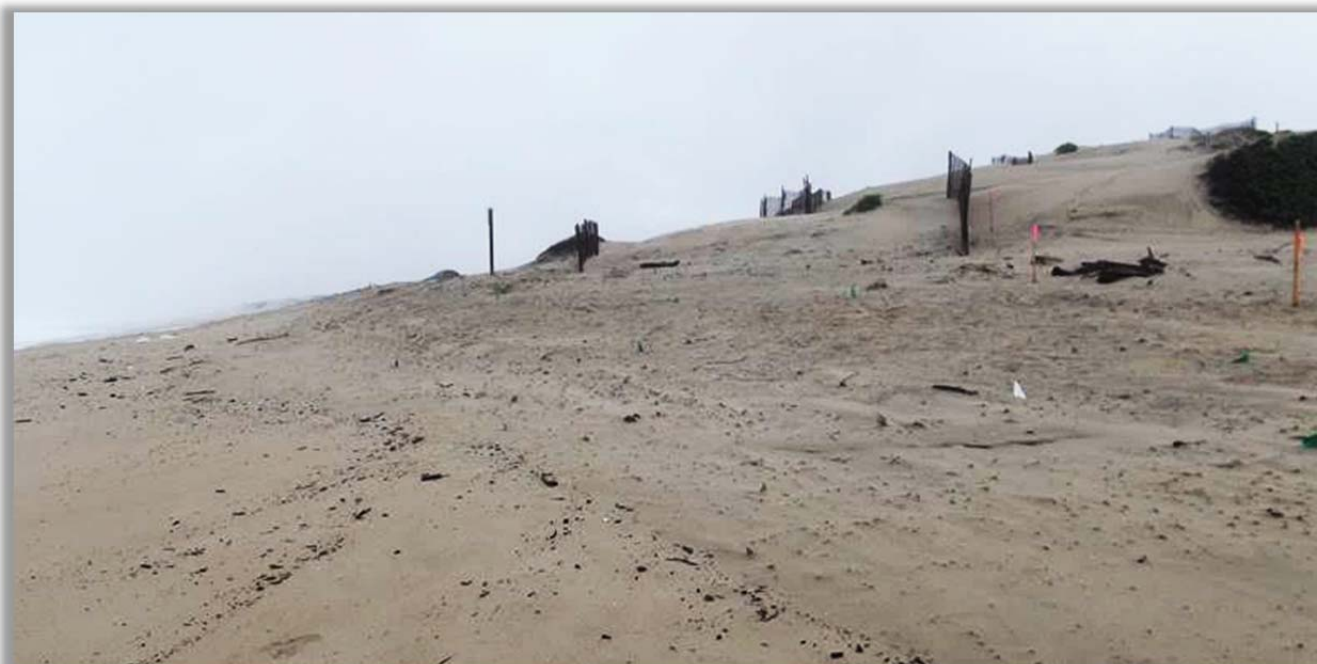
8X Site prior to any ground disturbance. Sand fence shows the area of the old 8X Remediation site.

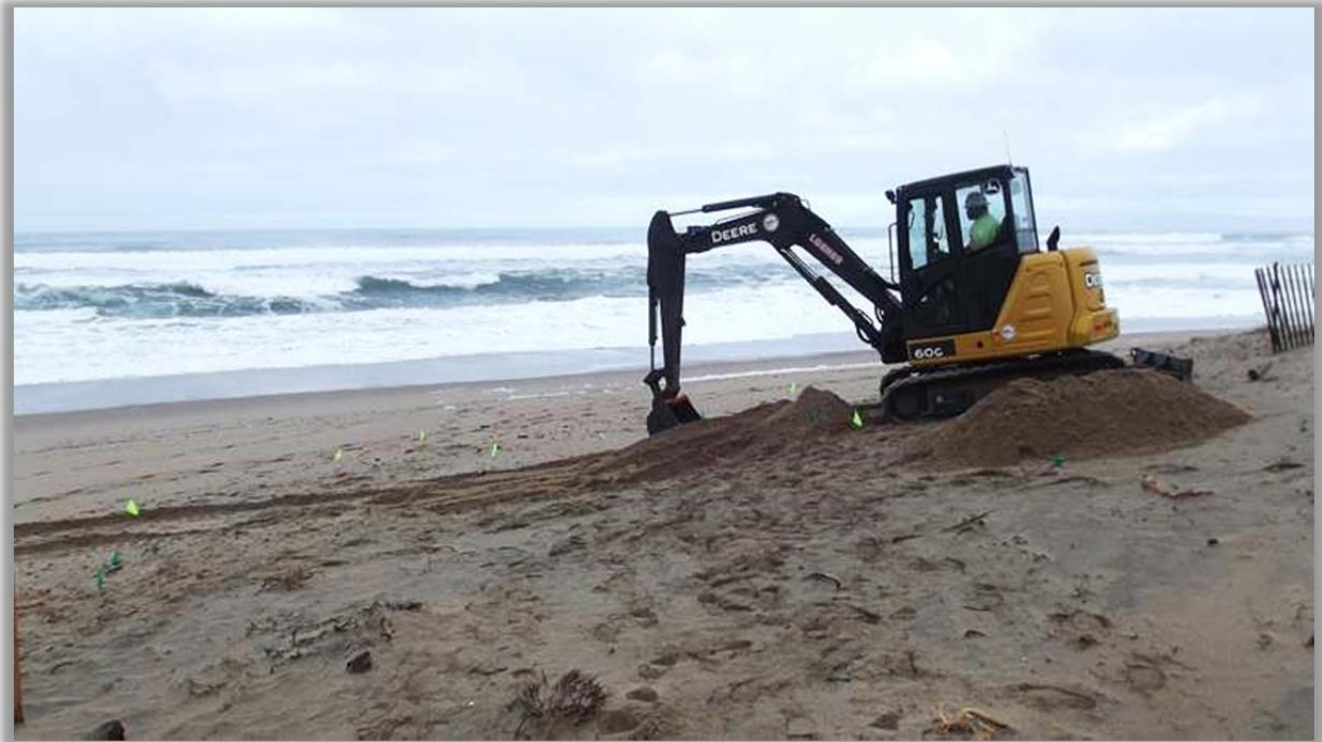
Mini-excavator used to clear clean overburden off of the sump material. This clean overburden will eventually be used to backfill over the excavation pit at the conclusion of excavation.

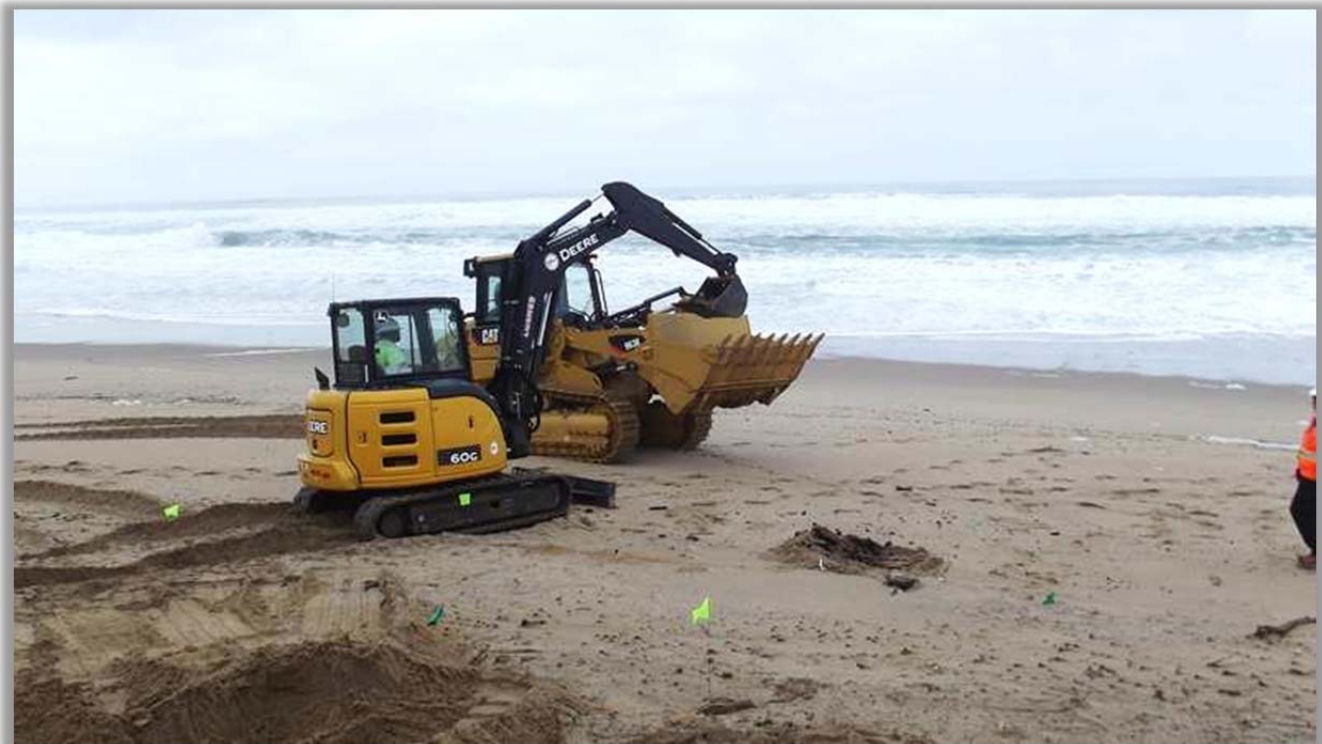
Sump material was loaded directly into the bucket of a tracked front-end loader which was then tracked back out along the beach and out the 7X Access Road. Sump material was dumped into haul trucks which then hauled the material to the M3 Stockpile Site.

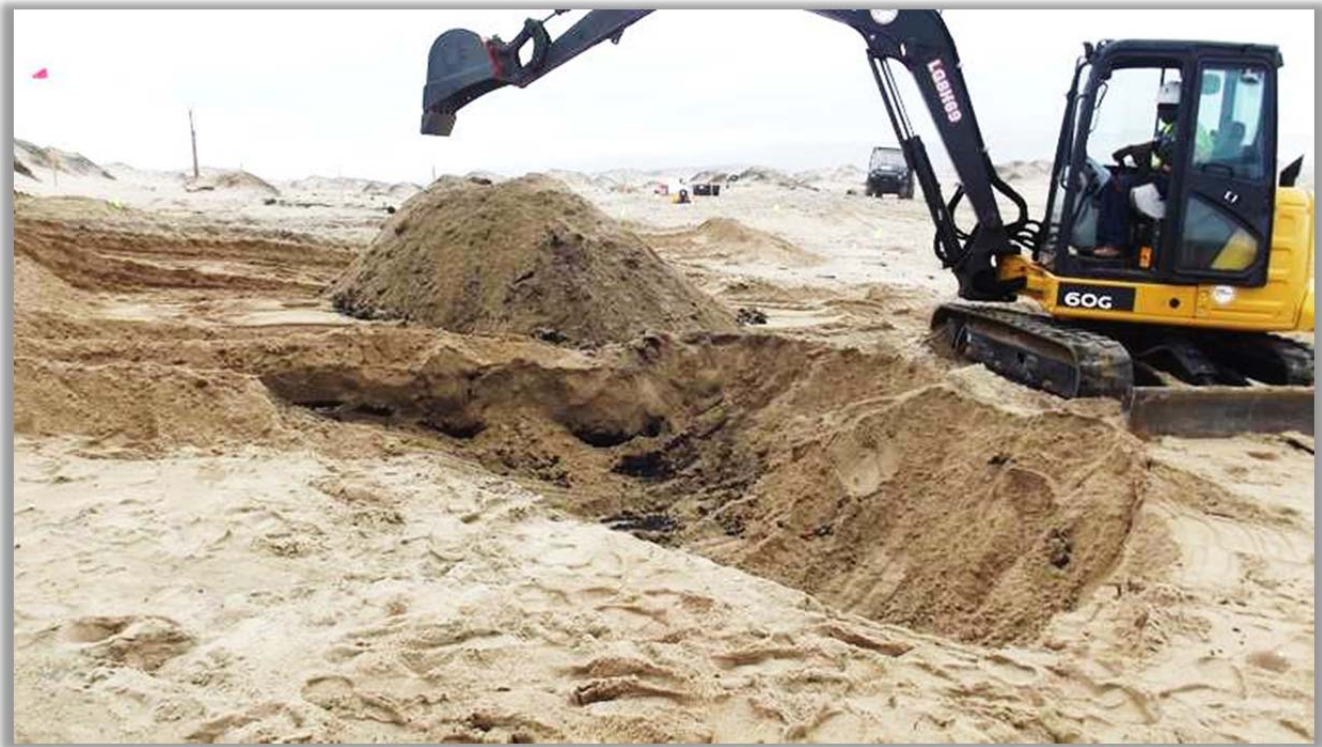
Excavating sump material. Although much of the exterior material was hard, deeper material in the interior of the sump was more pliable.

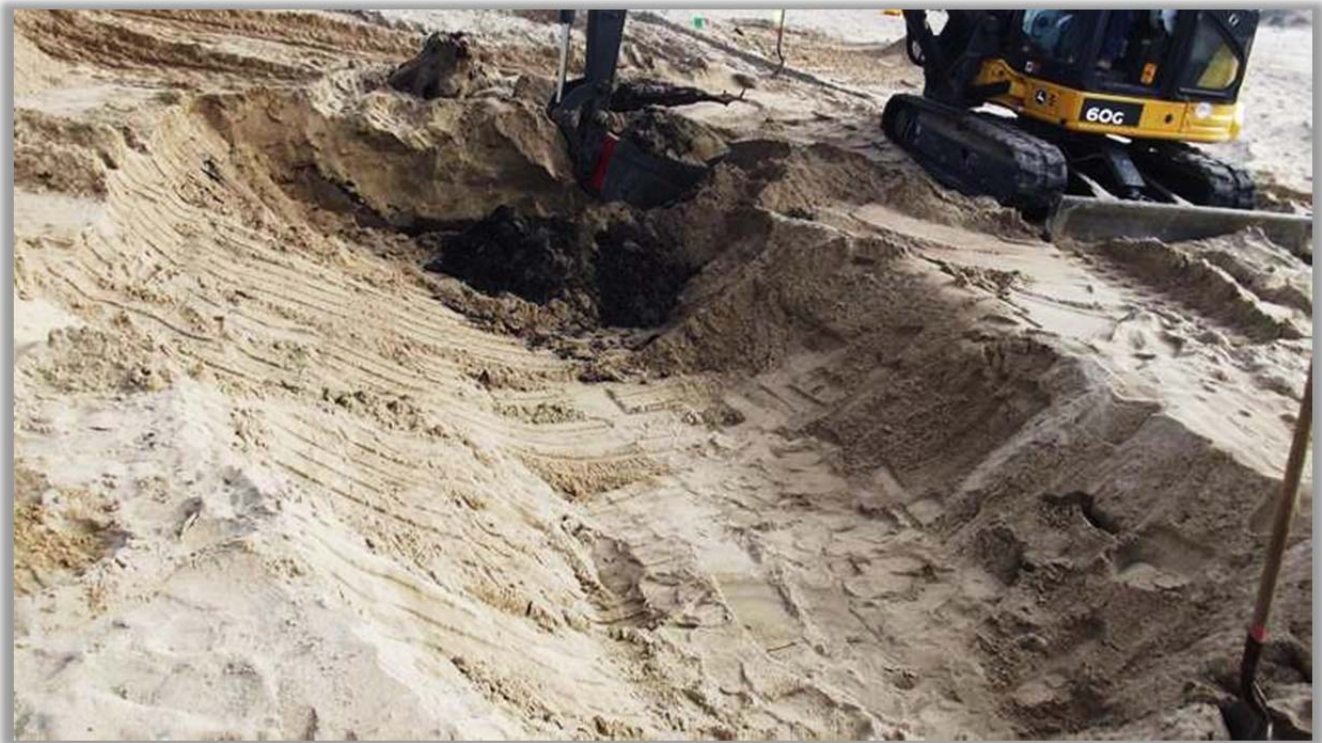
As visible in the photo above, the sump material was excavated to an approximate depth of 2-3 feet. The area was sampled and will be backfilled with clean overburden after all the sump material has been removed. Chevron anticipates at least one additional full day of excavation.
