County of San Luis Obispo Onsite Environmental Coordinator
Guadalupe Update 2-18-2016

Construction/remediation activities continue at the Chevron Guadalupe Oil Field Remediation Site (Field) this week. The San Luis Obispo County Onsite Environmental Coordinator (OEC) continues to be present at the Field on a daily basis.

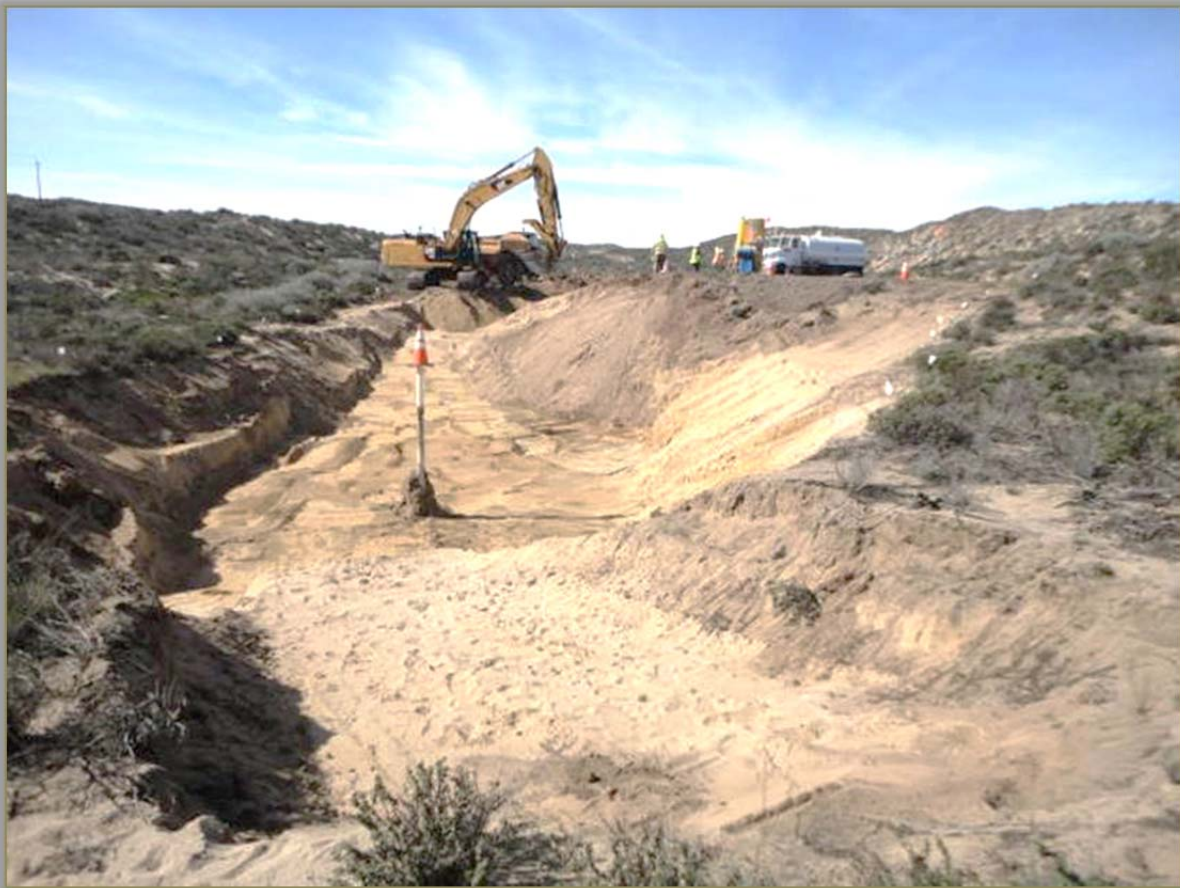
K12 Sump and Diluent Stain Removal. All of the sump material encountered in the excavation of this site was excavated; all of the diluent-contaminated soils were excavated to depths greater than four-feet deep.

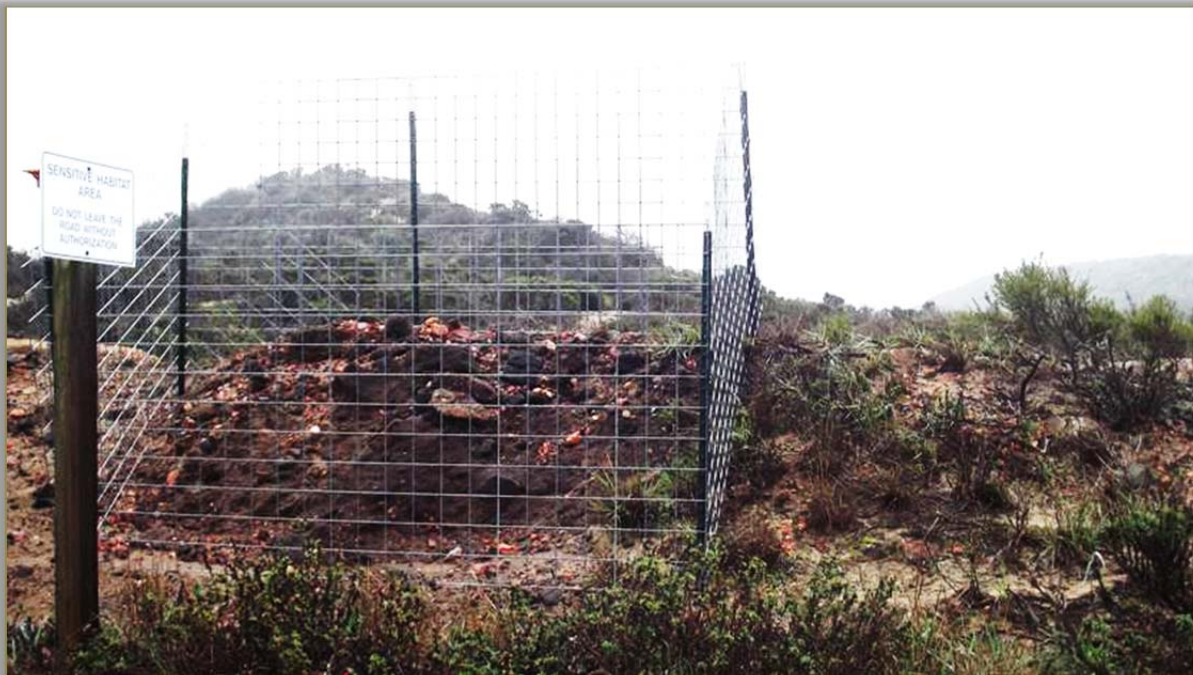
Hog-proof fencing: installed around several of the diluent surface stains across the Field to reduce potential for wildlife exposure prior to these areas being remediated. Wild hogs and other wildlife have been observed "wallowing" in these diluent-affected areas.

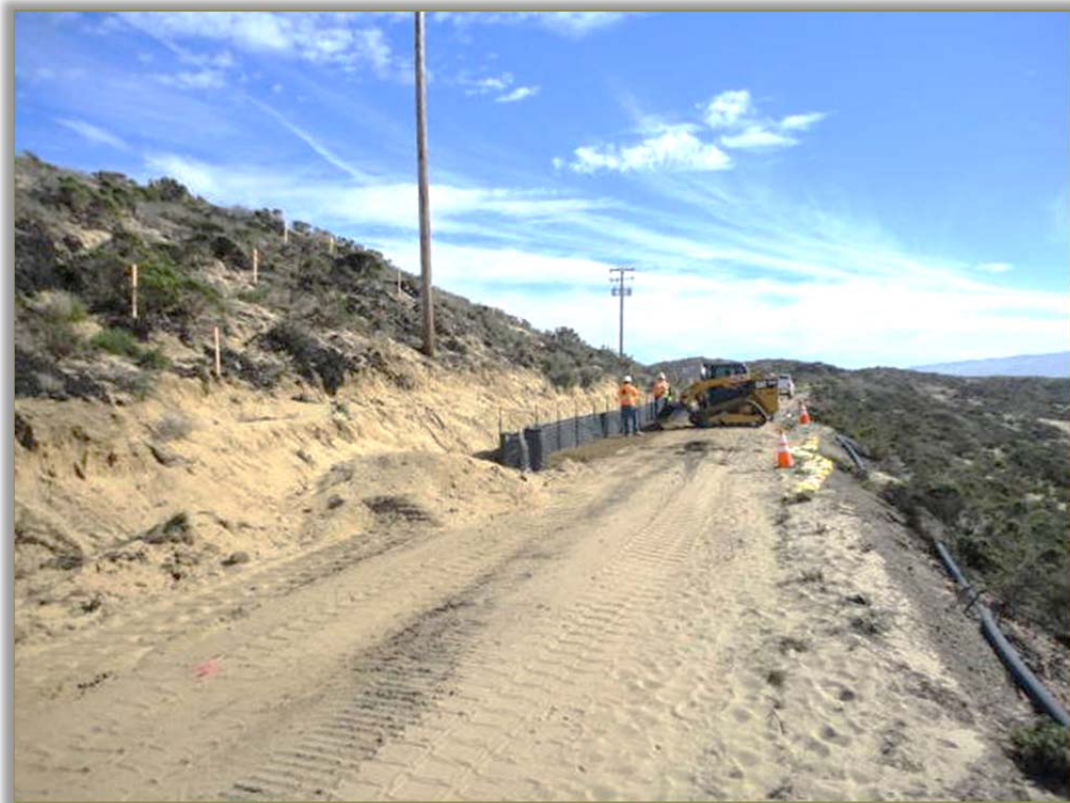
TB9 Recovery Well Road; road was widened to allow construction-related equipment safe access to the J14, I12, and I13 PROs Treatment areas. Construction team substantially reduced originally approved impacts to native habitats.
