County of San Luis Obispo Onsite Environmental Coordinator
Guadalupe Update 5-12-2016

Construction/remediation activities continue at the Chevron Guadalupe Oil Field Remediation Site (Field) this week. The San Luis Obispo County Onsite Environmental Coordinator (OEC) continues to be present at the Field on a daily basis.

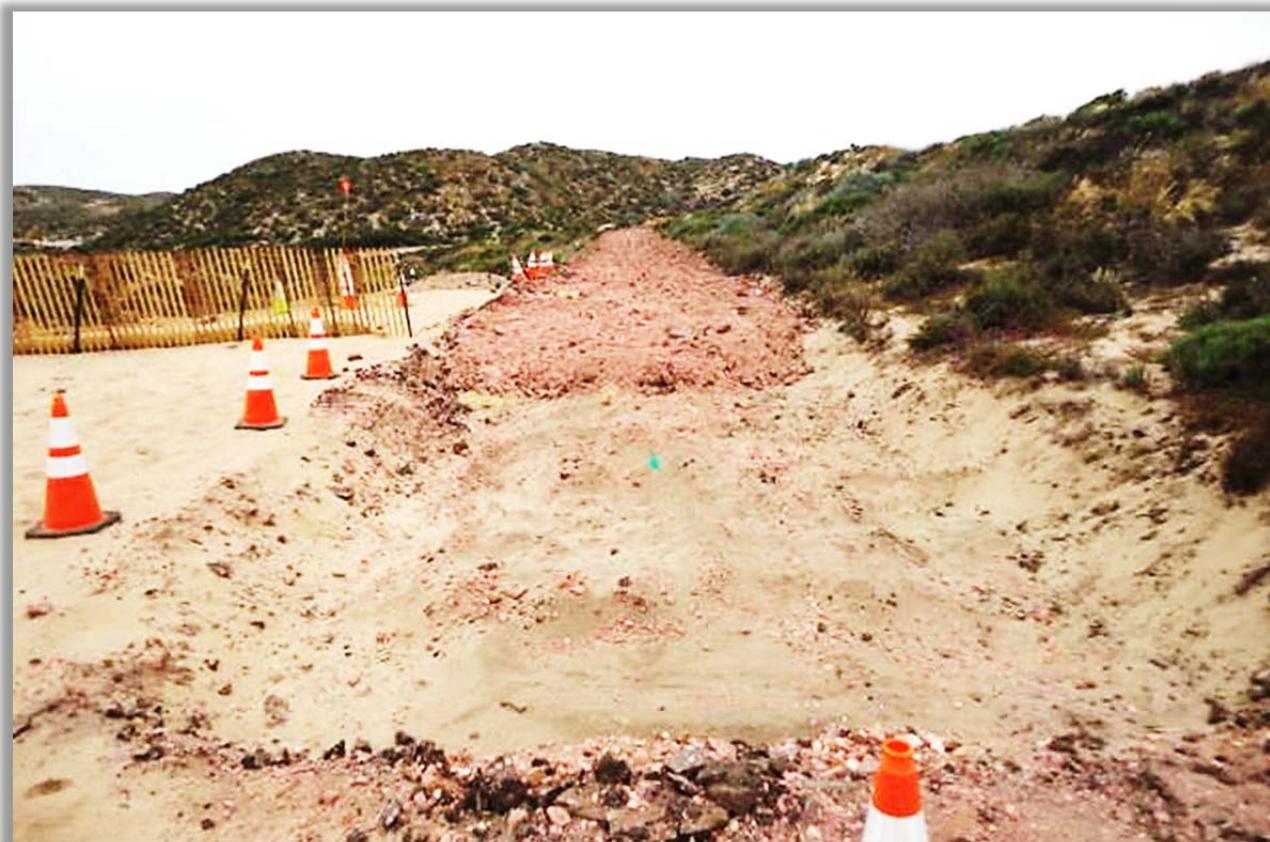
Access Road to the K11 Pad Site. Entact has treated the road using the excavator and claw, samples were collected and analyzed, and data was provided to OEC for review and backfill approval. Entact will now place clean sand over the treated area, mix clean sand into the red-rock, and install BMPs for erosion control.

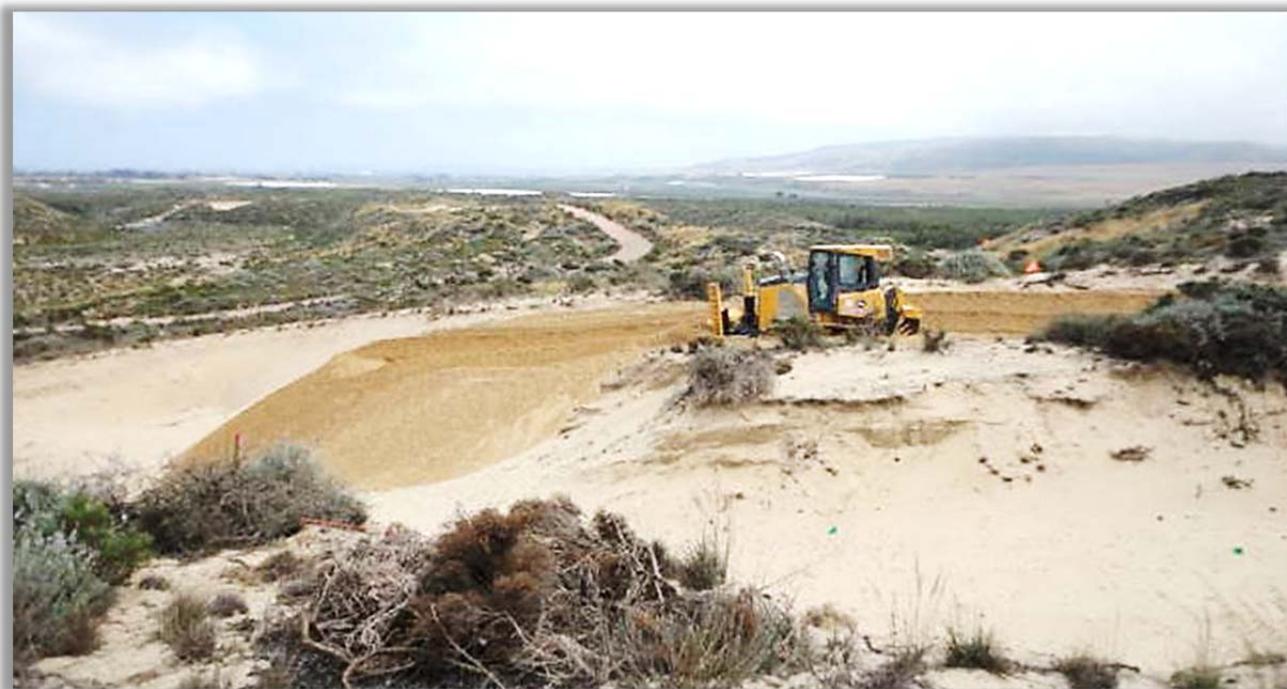
I12 Excavation. Diluent-contaminated material was excavated from this site; samples were collected and sent to the RWQCB for review and backfill approval. After RWQCB gave approval the site is backfilled with clean sand from the Q4 Borrow Site, regraded, approved by OEC for final grade, and BMPs are installed for erosion control.

- The Chevron/Padre team has completed excavating the I12 Diluent Surface stain, has received backfill approval, and is currently backfilling the excavation area with clean backfill from the Q4 Borrow Site.
- Two access roads were graded and installed using plastic inter-locking mats, one of which is being used for backfill operations.
